# Uneventful Until

By Lt. Mark Katocs

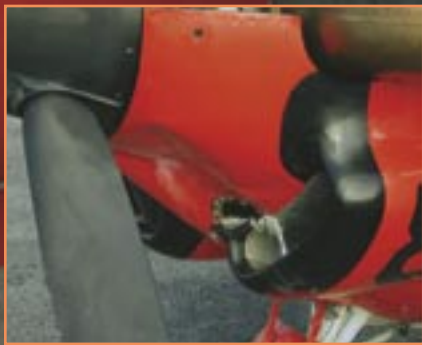
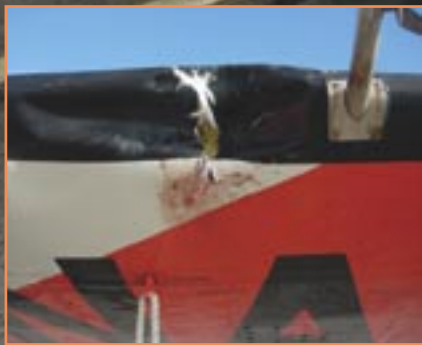
The postflight revealed at least two impacts from what was later determined by the BASH experts to be Cattle Egrets, which have a three-foot wingspan and a body length of 19 to 23 inches. Both impact sights tore the aircraft skin and left significant holes on the leading edge of the left wing and the accessory air intake on the nose cowl. Other damage was to the propeller spinner and the underside of the nose cowl above the intakes, which sustained serious deformation.

Maintenance later determined a rib on the wing also had broken as a result of the strike. Because of the near collocation of the angle-of-attack (AoA) probe and Pitot tube on the left wing, a single bird knocked both of these gauges out of calibration and effectively rendered useless all airspeed and stall indications. Using the GPS groundspeed proved to be the most effective indicator of flying airspeed. 🦅

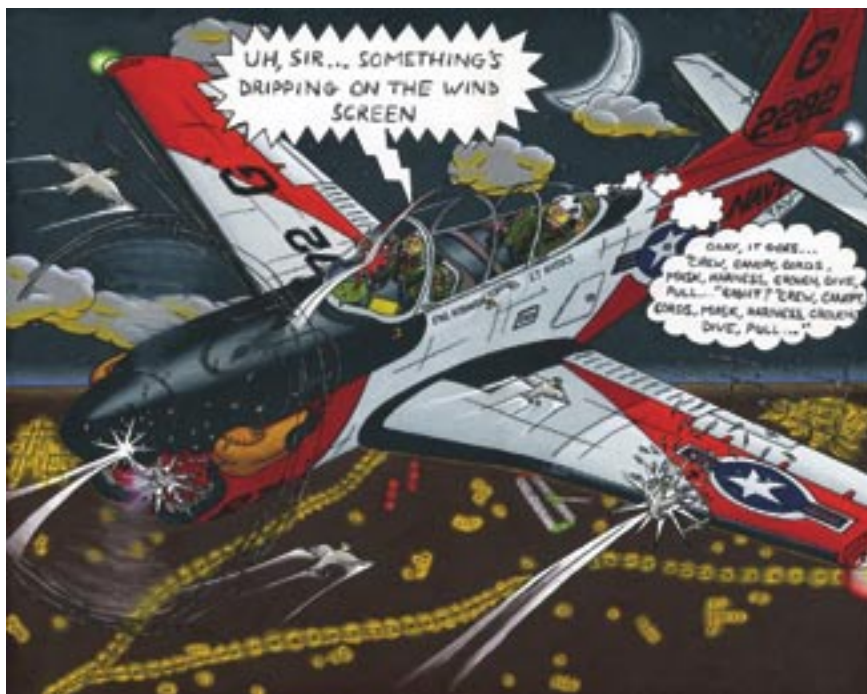
Illustration by Lt. Bard Hubbard, VT-27.
